ROYAL SWEDISH
GEOTECHNICAL INSTITUTE
PROCEEDINGS
No. 4

THE LANDSLIDE AT SKÖTTORP
ON THE LIDAN RIVER

FEBRUARY 2, 1946

STEN ODENSTAD

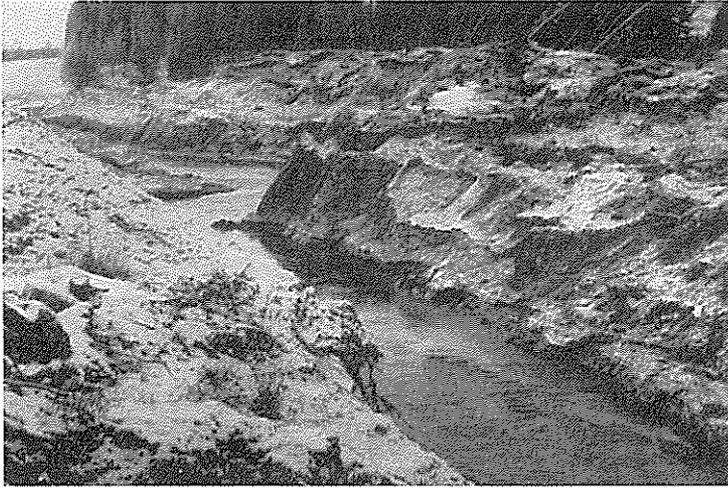
Fig. 5. River channel in slide area in December, 1946.

Lidan cut successively down through the clay in a canyon-like form. Slides occurred from time to time in the steep clay banks, and were sometimes so large as to cause temporary damming. However, the peaks of the water level graph in Fig. 4 are generally due to increase in runoff after abundant precipitation. Fig. 5 represents the river bed through the area of the slide in December 1946, and Fig. 6 gives the appearance of the river in October 1950. The eddies in the

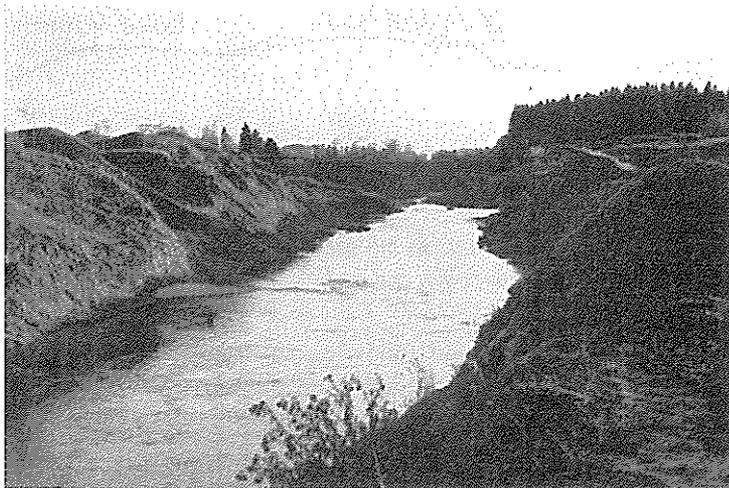
Fig. 6. River channel in slide area in October, 1950.

latter photograph show that the river is still slightly dammed up; before the landslide the water was relatively calm at this place.

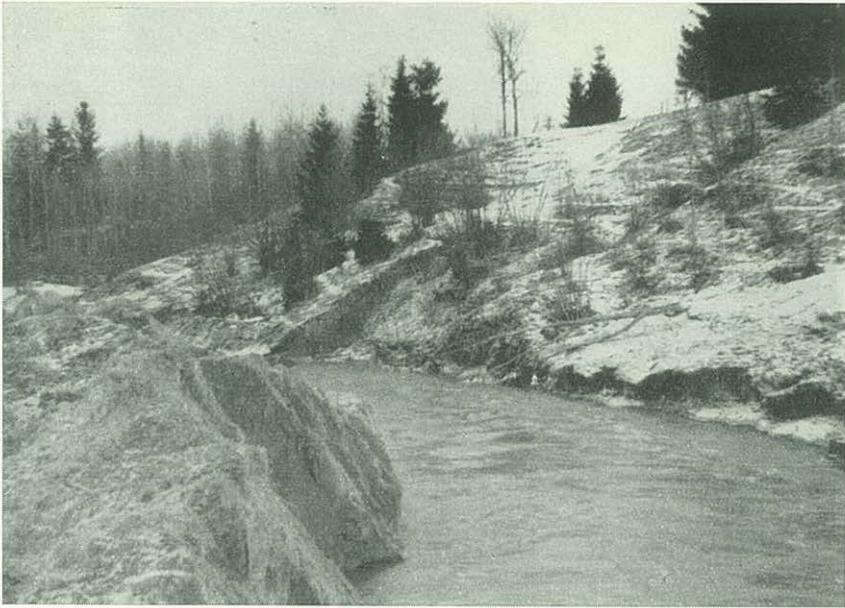
Fig. 7. The Lidaberg slope, viewed from the upstream end of the island, in process of erosion.

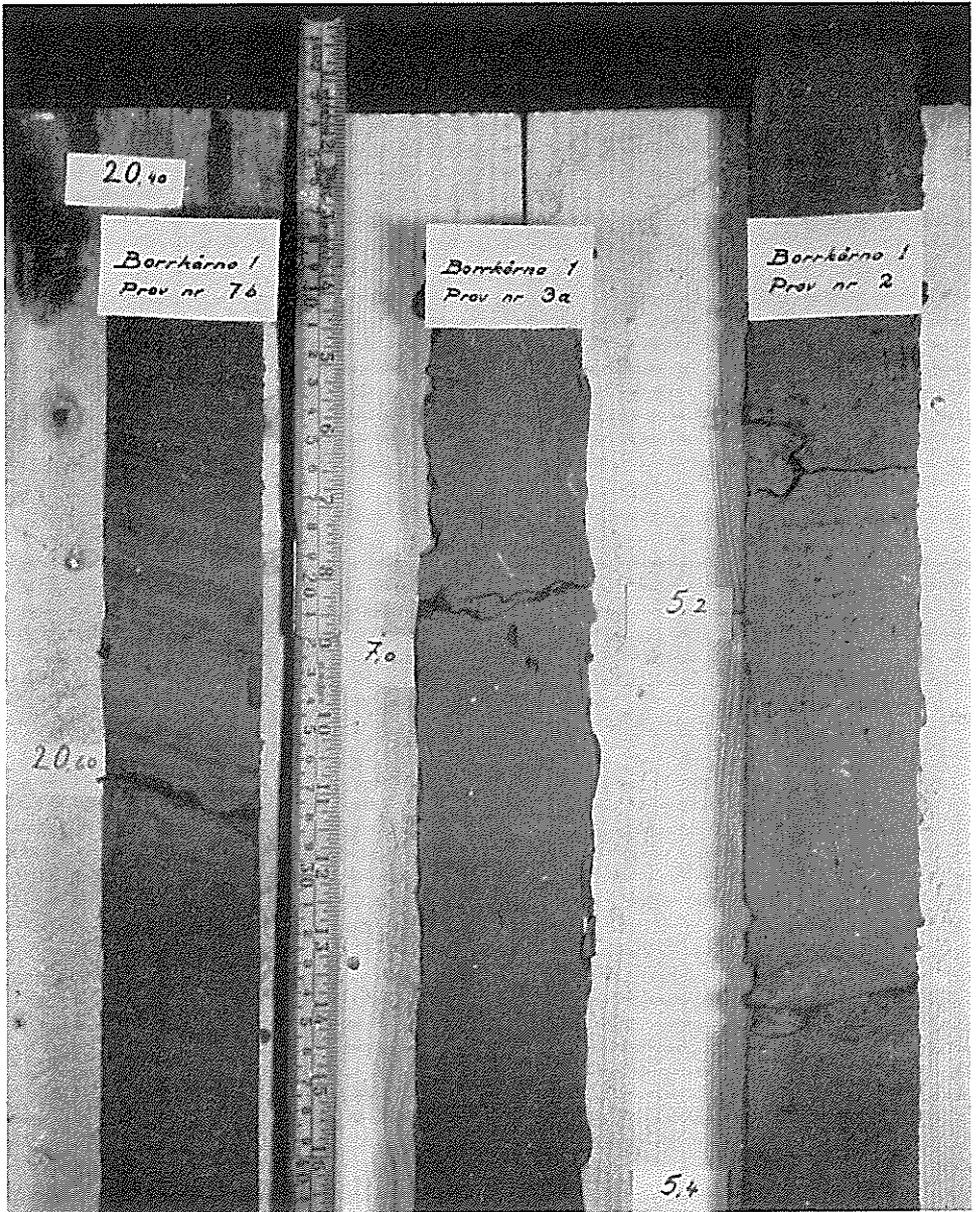
The detailed examination of the clay cores extracted by the sampler with metal foils (Tables 1 and 2) shows that grey, partly silty, black-stained clay alternates with brown, dark-banded varved clay down to a depth of approximately 8 m in both holes; the contact surfaces between the different clay strata are folded and heavily perturbed. According to Caldenius, the varved clay is partly proximally formed, and the alternations of strata must therefore

Fig. 14. Clay core taken in Section I in vicinity of Bore hole 4. Appearance at depths of 5.2, 7.0, and 20.6 m.

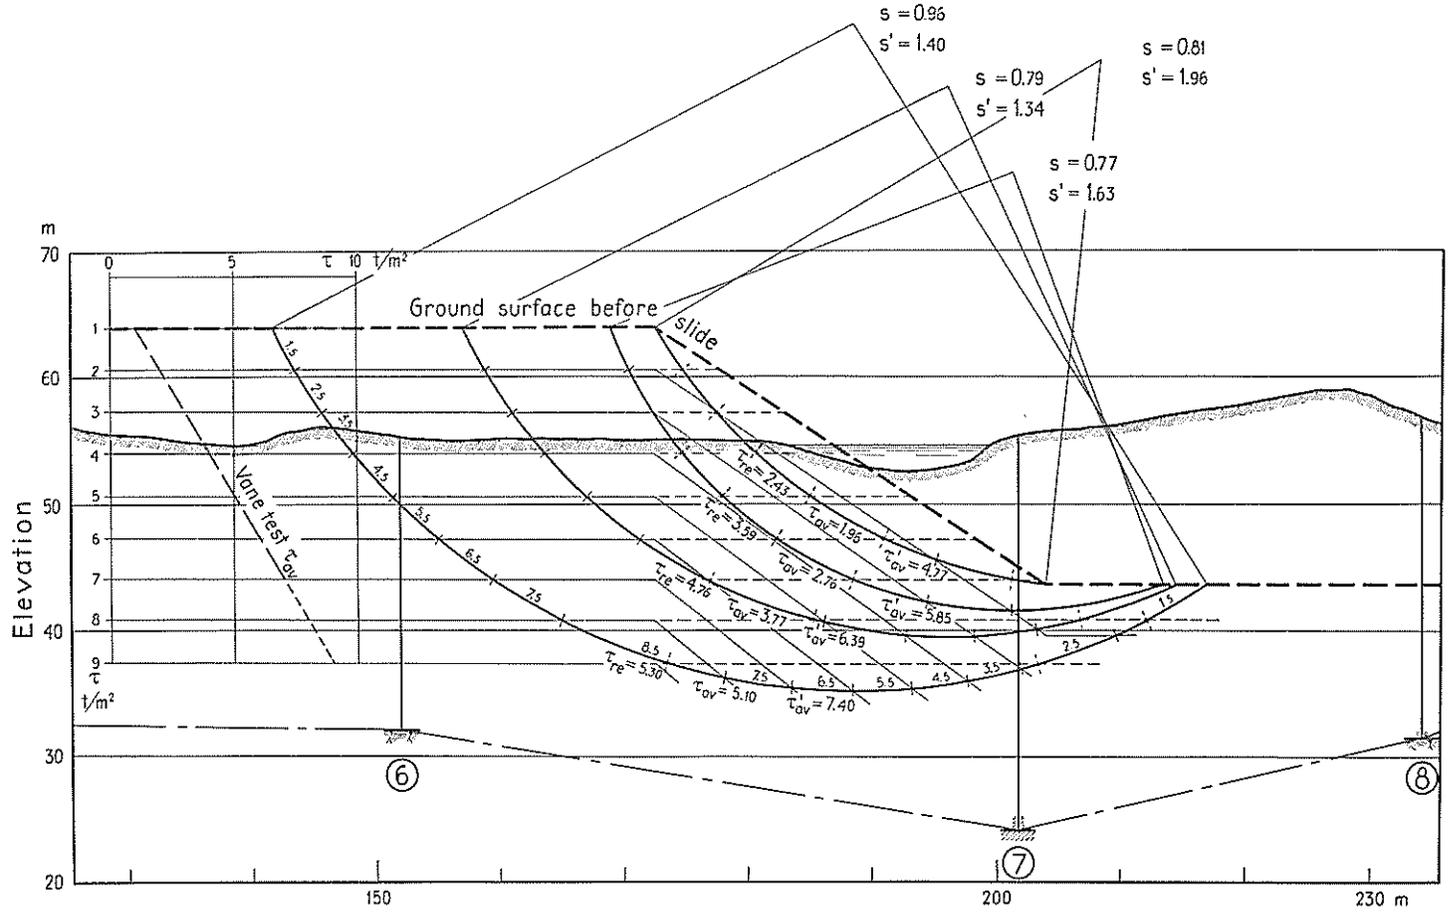
Fig. 22. Stability of river bank computed by Swedish circular-arc method.

The appearance of the bank before the slide is not known with certainty, but assuming that it was as shown in Fig. 22, its stability was computed by the circular-arc method. The shear strength of the soil behind the slope was assumed to vary with the depth below the surface according to the straight line in Fig. 22, which represents an average of the results from the three bore holes made with the vane borer. For the variation of the shear strength below the slope two assumptions were made: that the lines of constant shear strength are horizontal, and that they are parallel to the slope. Using the vane test results in this way, the factor of safety of the bank was found to have been between 0.77 and 1.34.

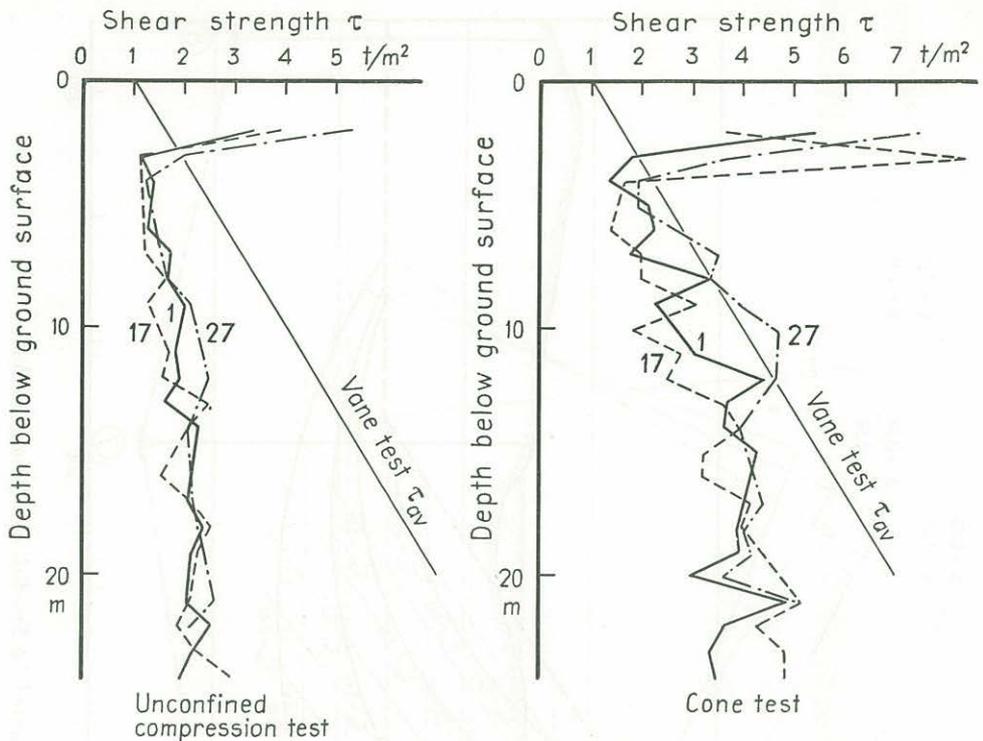
Fig. 23. Shear strength from unconfined compression test and cone test in Bore holes 1, 17, and 27—the values are representative for all bore holes—and the average result of the vane boring.

Fig. 23 shows the shear strength values obtained by different methods from various bore holes. For the sake of clarity, only the results from some of the bore holes are given, but these results are representative. It is seen that the shear strength values from the unconfined compression test and from the cone test are lower than those from the vane test; if used for computing the stability of the slope, they result in safety factors of, say, 0.4 and 0.6 respectively. This result confirms that the slope was severely strained before the slide.

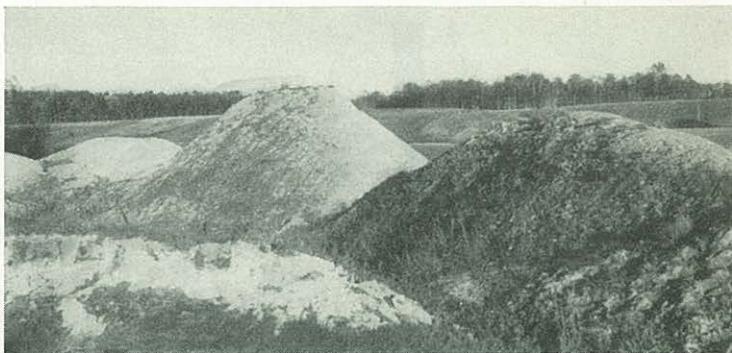
Fig. 28. Cavity after slide at Kroken.

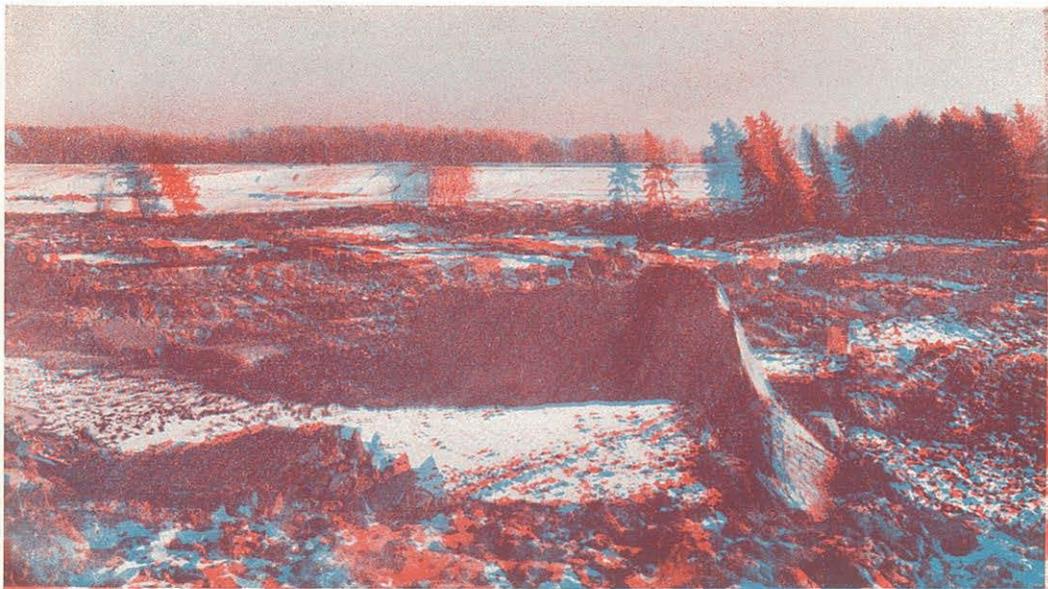
Pl. V. View of cavity after slide. Anaglyphic stereo-photo taken from point A in direction of arrow, Fig. 3.

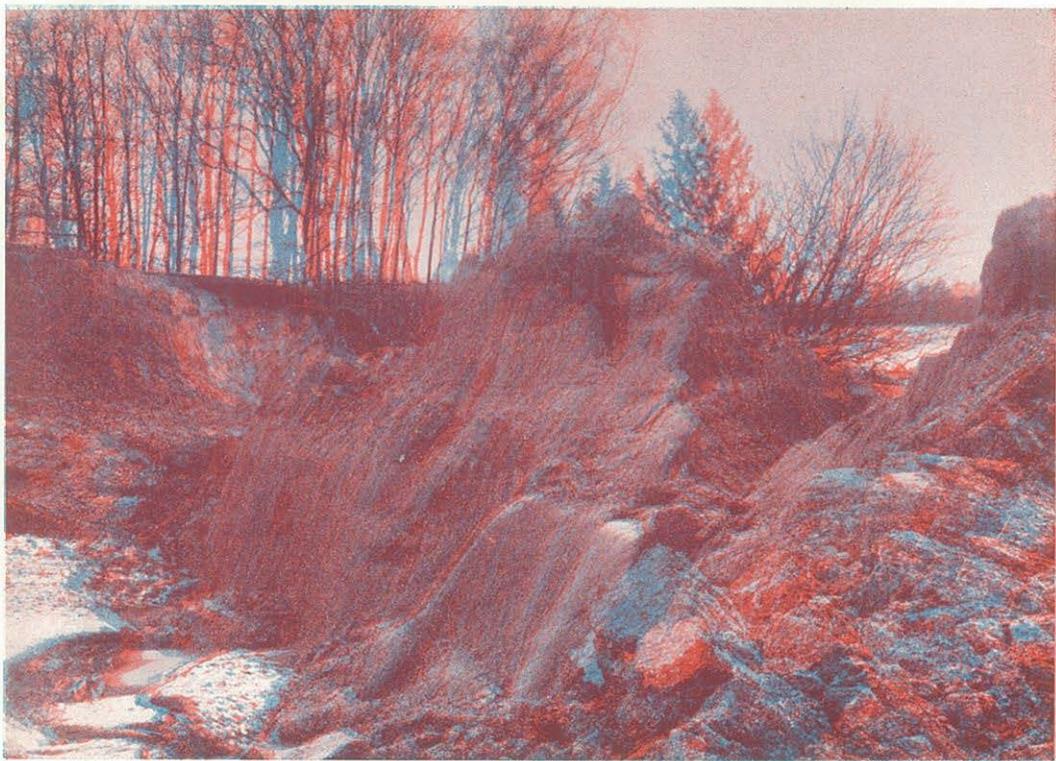
Pl. VI. Anaglyphic stereo-photo showing clay ridge.
