ROYAL SWEDISH
GEOTECHNICAL INSTITUTE
PROCEEDINGS
No. 4

THE LANDSLIDE AT SKÖTTORP
ON THE LIDAN RIVER

FEBRUARY 2, 1946

STEN ODENSTAD

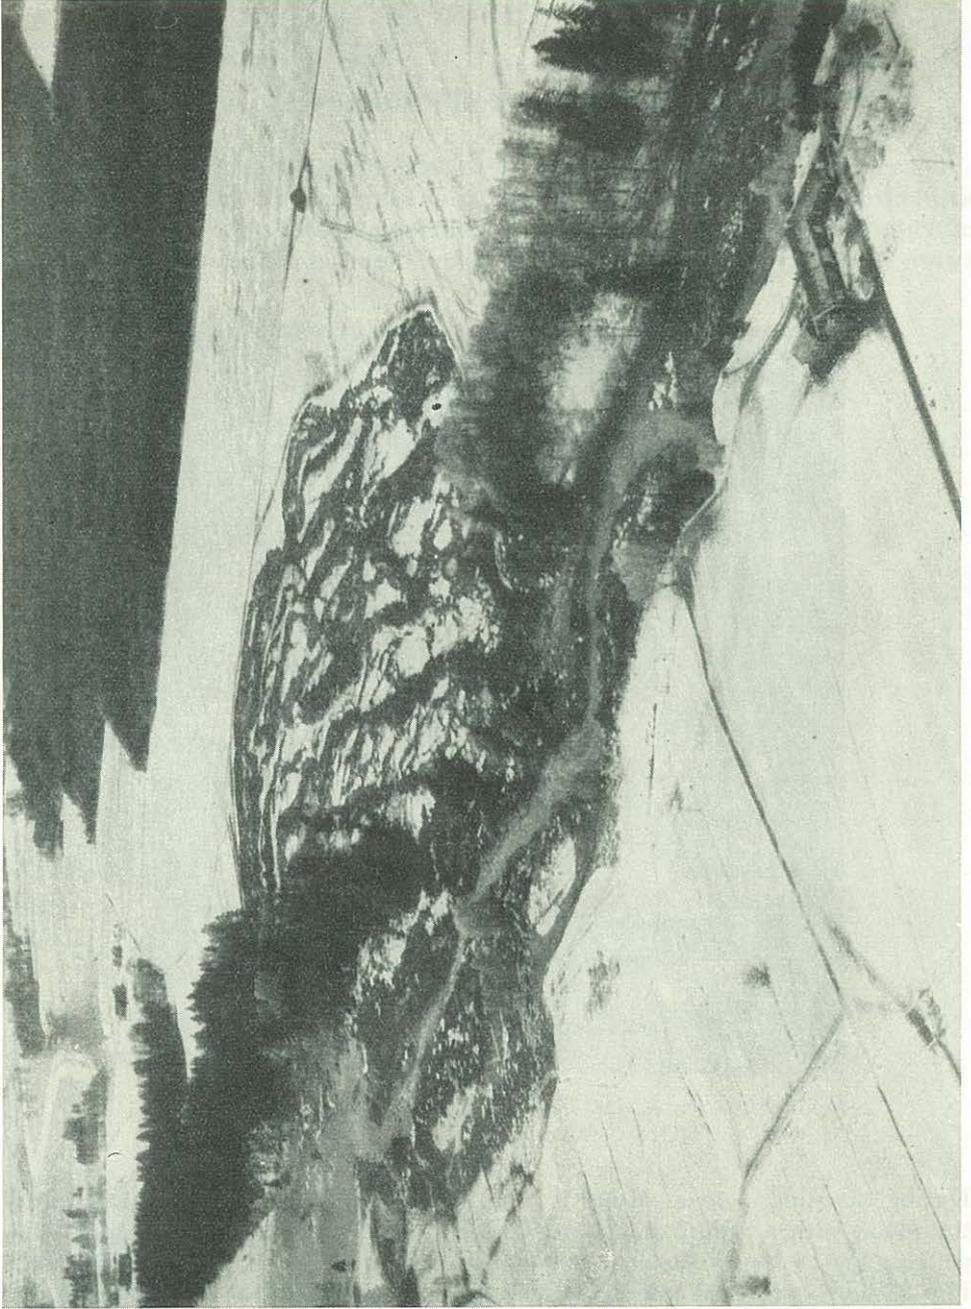
During the slide, a mass of earth from an approximately semi-circular area of the plain, with a radius of 175 m, slipped towards the river, damming it completely. Fig. 1 shows the location of the landslide on the topographical map. Fig. 2 shows an aerial photograph of the slide area, Fig. 3 gives a plan¹, and

Fig. 2. Aerial photograph of site. (Copyright Ostermans Aero AB.)

Downstream of the slide, soil masses from the slide had been deposited on the bottom of the river and formed an island, whose downstream end was located straight in front of the Lidaberg farm. The island is visible on the plan in Fig. 3 and in the lower right-hand corner of the aerial photograph in Fig. 2. Soon after the water had begun to run over the clay plug, the channel on the Lidaberg side of the island was found to develop considerably faster than that on the Sköttorp side. As a result, after some days, all the water was flowing on the Lidaberg side. The island, at least its upstream end, consisted of very firm clay, which was not visibly eroded. On the other hand, considerable continuous erosion took place on the Lidaberg slope (Fig. 7). The erosion reached its maximum off the two ends of the island owing to the more marked change of direction of the bed at those places. Borings in and behind the 15 to 20 m high Lidaberg slope showed that the erosion, if allowed to continue, was liable to produce a new slide in that slope. The danger of this slide was considered so great that the occupants of the Lidaberg farm temporarily moved from the farm, and spent there only the time necessary for their daily work. To prevent a slide, it was very important to help the river to move to a safer location. It was therefore decided to dig a new channel through the island from end to end and to close the Lidaberg channel at the upstream end of the island. Moreover, the then dry channel along the Sköttorp side was to be filled in,

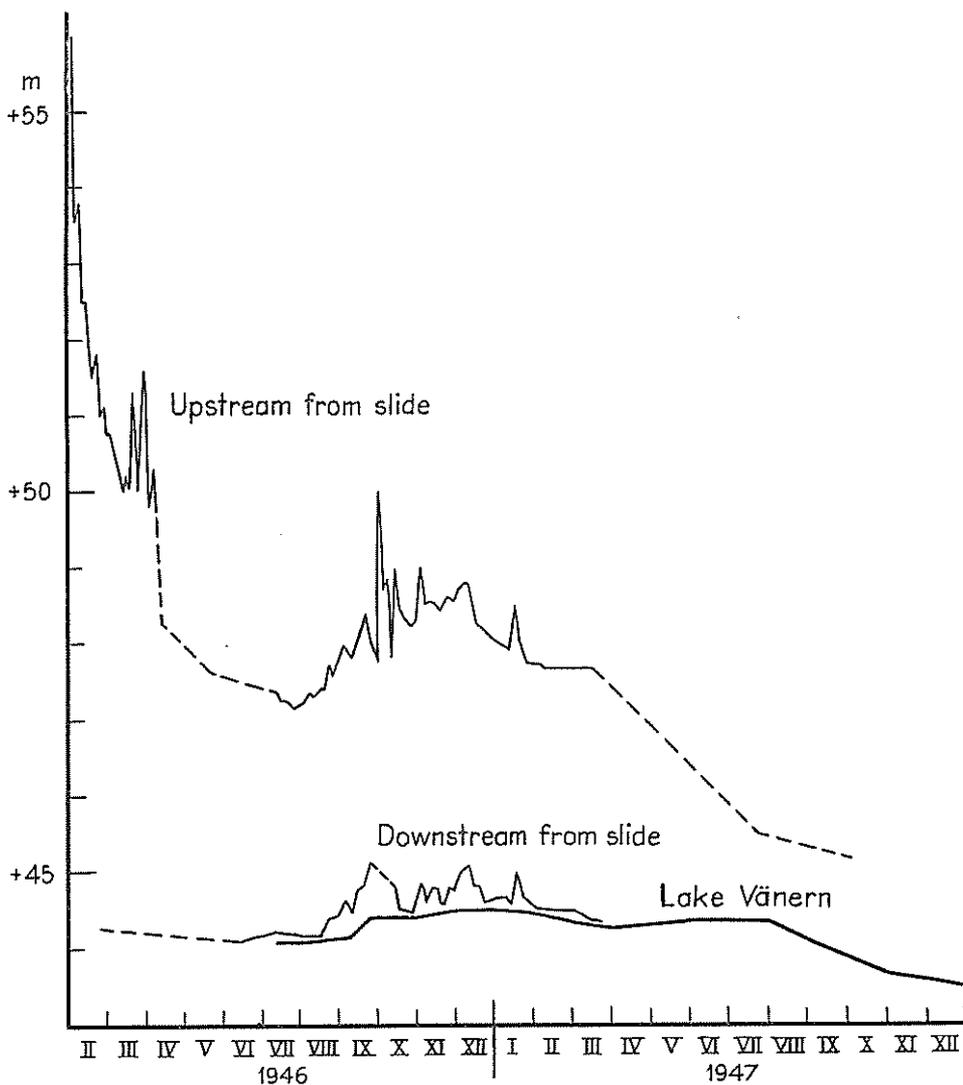
Fig. 4. Diagram showing variations of water levels upstream and downstream from slide, and in Lake Vänern.

Fortunately, the fear of a flood following the cutting-through did not materialize¹. The cutting-through proceeded very slowly, as shown in Fig. 4, which represents the variations in upstream water level up to October 1947. The

Lidan cut successively down through the clay in a canyon-like form. Slides occurred from time to time in the steep clay banks, and were sometimes so large as to cause temporary damming. However, the peaks of the water level graph in Fig. 4 are generally due to increase in runoff after abundant precipitation. Fig. 5 represents the river bed through the area of the slide in December 1946, and Fig. 6 gives the appearance of the river in October 1950. The eddies in the

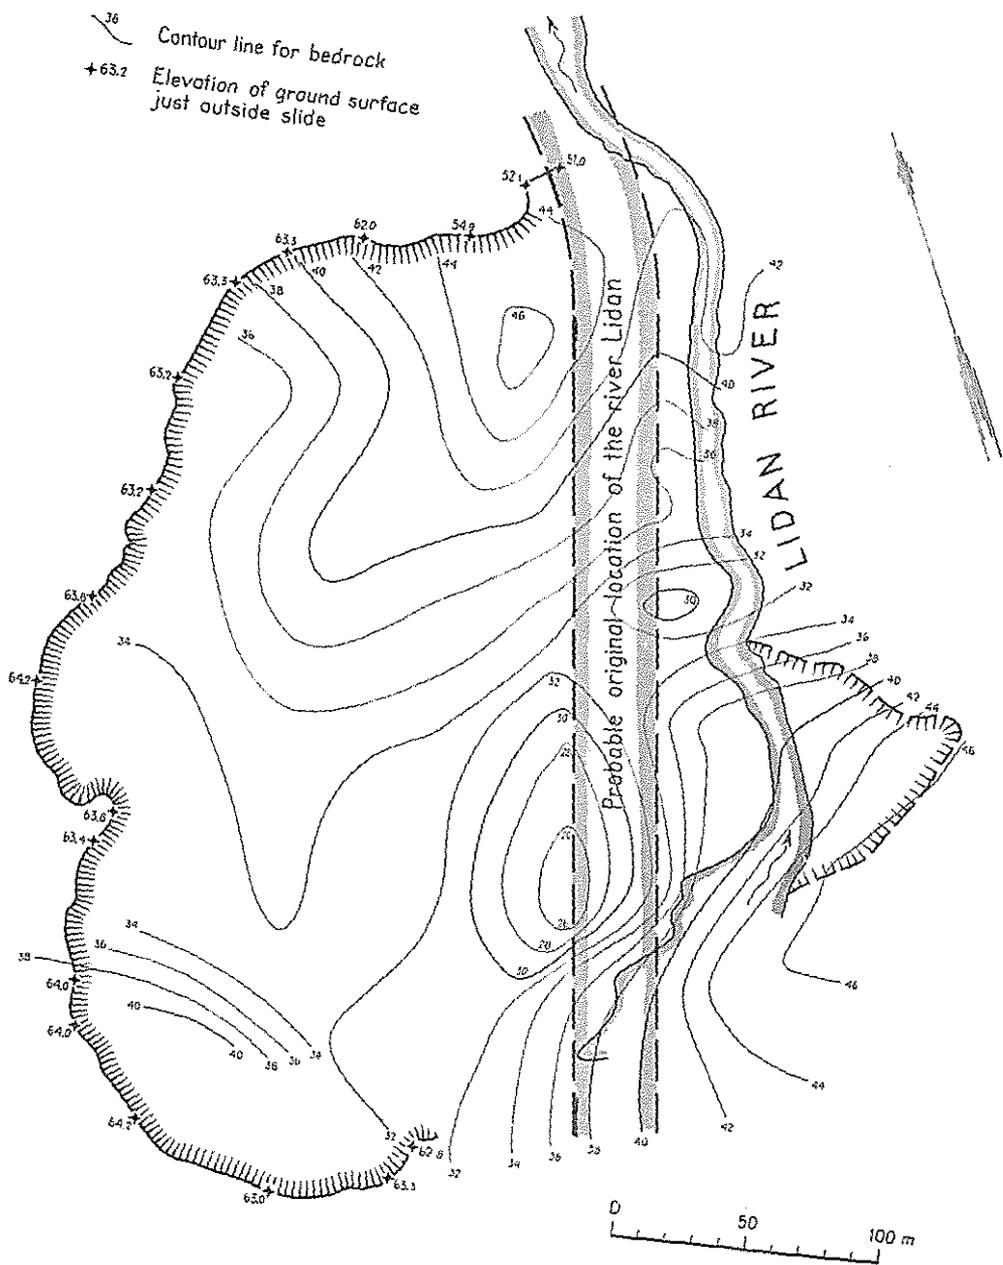
Fig. 13. Contour lines for bedrock in slide area. Probable location of the Lidan River before slide is indicated.

According to the above description of the mechanics of the slide, there is a particularly serious danger of an initial slide starting a large retrograde slide either if the clay strata slope towards the initial slide, or if quick (or at least sensitive) clay occurs to a greater or lesser extent. From Fig. 13 it can now be seen that the firm bottom at Sköttorp does not slope towards the river, and for this reason it cannot be assumed either that the layers of the clay do so. It thus appears probable that the sensitive clay at Sköttorp is the reason why a large retrograde slide followed after the bank had slipped into the river.

At Kroken, on the eastern bank, directly opposite the upstream part of the Sköttorp slide, the Lidan has cut down since the slide into a more easterly position than formerly, as is also shown on the map, Fig. 13. In the elevated area, which juts out here between two old slide cavities, several slides have then occurred. The largest of them took place in the middle of May, 1946. A photograph of this secondary slide area taken in October, 1950, is shown in Fig. 28. Fig. 29 shows a plan of the area and Pl. IV represents the results from one of the sections which were bored to investigate the danger of slides to some farmsteads directly behind the area. (The bore section on Pl. I, which was made before the slide, is at the edge of the area.) It appeared that a considerable quantity of quick clay lies underneath the farmsteads, and is separated from the river bed by clay which is not quick. Both the stability analysis on the basis of the strength values and the slides which have actually occurred prove that the bank is under severe stress. As shown by the eddies in Figs. 6 and 27, the river, after the slide, has not yet cut down to its base-level. For this reason, the stress in the bank will increase somewhat even apart from the influence of any future, temporary increase of the ground water pressure. If a new slide should occur and should reach the quick clay, there is evidently danger of its spreading backward and affecting the farmsteads concerned.

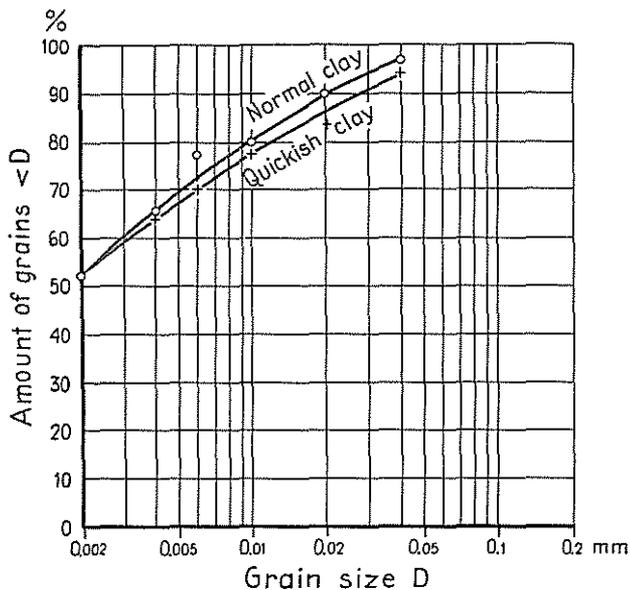
Fig. 15. Grain size distribution for two clay samples from Section I. One sample, taken from Bore hole 4 at a depth of 10 m, is neither quick nor quickish ($H_3 = 172$, $H_1 = 7$). The other, taken from Bore hole 1 at a depth of 22 m, is quickish ($H_3 = 172$, $H_1 = 1.1$).

ed clay almost resembles a liquid. Such a clay is called a quick clay. In approximate agreement with Per Holmsen (7), quick clay is here defined as a clay in which the H-ratio H_3/H_1 is greater than 50, while H_1 is at the same time less than 1. (The H-ratio is thus a measure of the sensitivity of the clay.) Where the H-ratio is greater than 50 but H_1 is greater than 1, the clay is designated here as quickish. Pls. I—III show that quick and quickish clays occur to a considerable extent in and close to the area of the slide. The investigation made by Rosenqvist (8) shows that quick clay has not a higher percentage of coarse material than ordinary clay. The grain size distribution — only above the diameter 2μ — has been determined for two Sköttorp clay samples. One of them was quickish, and the other was neither quickish nor quick. The results are stated in Fig. 15. In this case, too, the grain size distribution does not indicate anything about the sensitivity. According to the Norwegian geologist Gunnar Holmsen, quick clay is produced by fresh ground water gradually washing the salt out of a clay formed by sedimentation in sea water; as a result, the structure of the clay becomes less stable and more sensitive to remoulding.

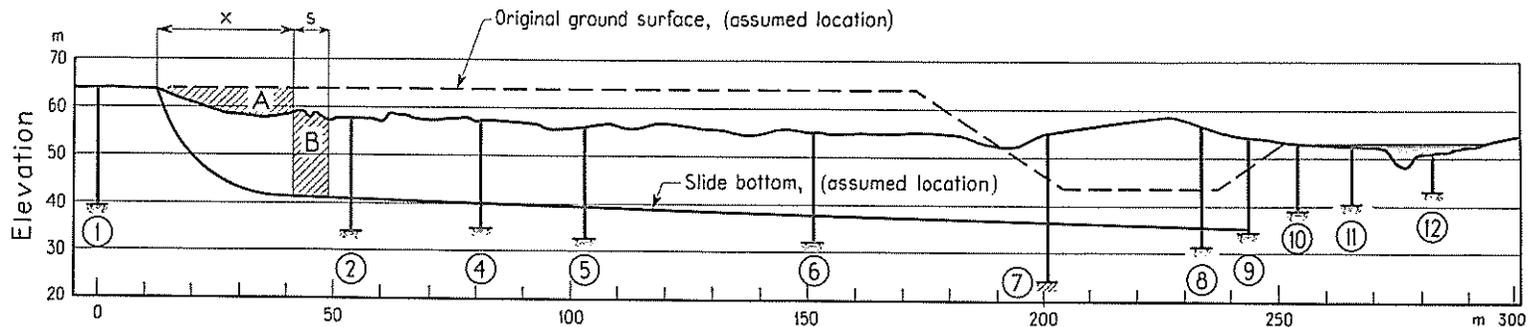
Fig. 16. Assumed locations of slide bottom and original ground surface, for calculating horizontal displacements in Section I.

A rough estimate of the size of the horizontal displacement at various distances from the edge of the slide has been made, using Section I and assuming that the original ground surface and the bottom of the slide are located as shown in Fig. 16. The displacement of any point of the ground surface of the cavity is assumed to be equal to the average displacement, s , of the vertical line between this point and the bottom of the slide. The displacement $s = s(x)$ of a point located at the distance x from the edge of the slide is then determined by the condition that area $B = \text{area } A$. The result is given in Fig. 17; from this it will be seen, for instance, that a point originally located 150 m from the edge of the slide was displaced 50 to 60 m towards the river. This value agrees quite well with the measure of the displacement of the river in Fig. 13, where the previous location of the river is indicated with the guidance of a map (admittedly questionable) dating from 1796.

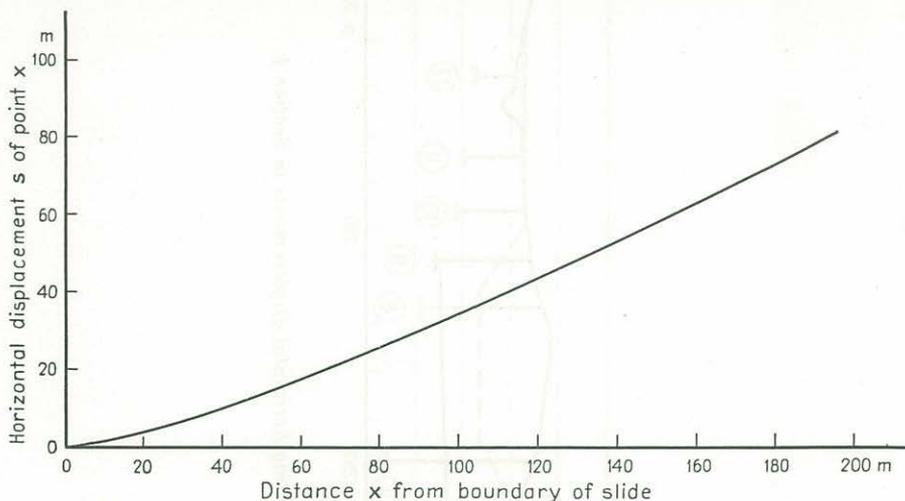
Fig. 17. Horizontal displacement s of point x metres from boundary of slide, computed by relationship $A = B$ (Cf Fig. 16) under assumption that slide bottom and original ground surface are situated as in Fig. 16.

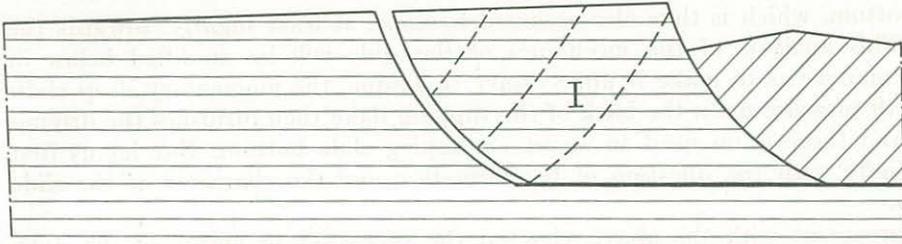
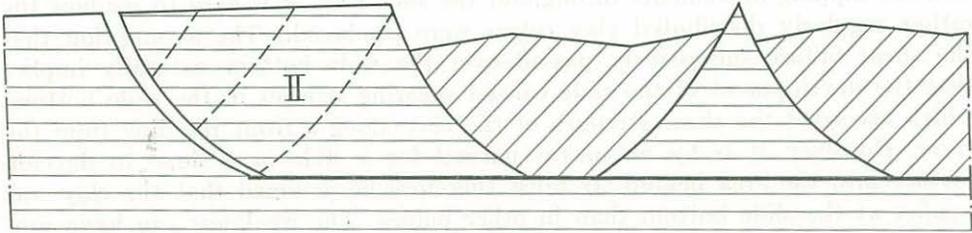
The clay ridges should be regarded as a sort of horsts, between which the ground has subsided and broken as the ridges moved away from one another. The slide process seems to have been as follows: a flake consisting of clay ridges separated by sunk and broken patches of ground, slipped towards the river on a relatively plane, only slightly inclined slide bottom. This flake probably comprised the larger part of the length of the slide area along the river, and grew retrogressively (i.e. in the direction away from the river) during the slide. As shown by the following description, the growth of the slipping flake was prob-

*Fig. 18. The ground pieces slip and break down. Sloping layers.
A deep cleft is supposed to open behind each slipping
piece and to remain in the first moments.*

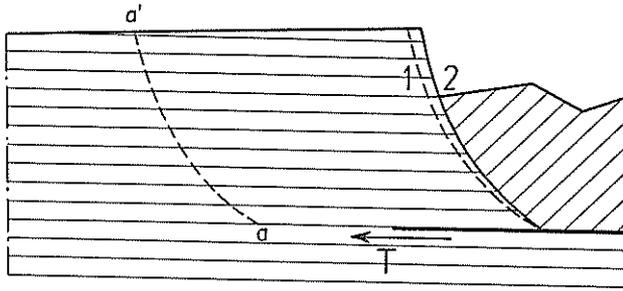
Fig. 19. The clay shears in a layer surface behind the bottom of a cleft when the remaining soil mass extends horizontally.

The course of events at the slide bottom at Sköttorp during the successive spreading of the slide away from the river can now be described as follows. Let us consider the remaining clay behind the cleft or break surface, in front of which the clay mass has begun to slip (Fig. 19). When the pressure on the wall of the cleft becomes zero, or — if no cleft is produced — when the pressure on the break surface is reduced, the remaining ground extends outward from position 1 to position 2. However, it is prevented from freely and immediately deforming because it is pasted, so to speak, to the base in the extension of the slide bottom already formed. Thus a stress concentration is produced in the extension of the slide bottom close to the cleft or the break surface, resulting in shear failure there. The stress concentration then travels in the slide bottom away from the river and the shear failure moves with it. As the failure spreads along the slide bottom, the shear force T , which can be mobilized on the right of each point, a , to maintain, together with the other forces in action, the equilibrium of the remaining ground to the right of section $a—a'$, is reduced. This can also be expressed as follows: the strain which $a—a'$ must be able to withstand in order to prevent the slide area from spreading further increases with the retrogressive development of the rupture at the slide bottom. Eventually the moment comes when the most strained section, $a—a'$, does not hold any longer, rupture occurs there, and another mass slips away.

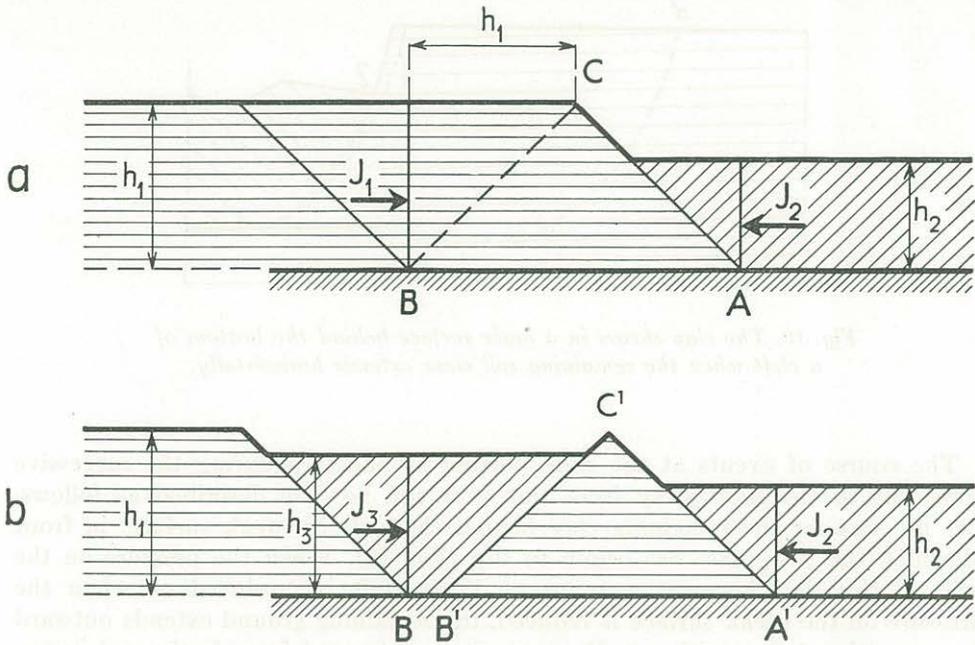
Fig. 20. The ground pieces slip and break down. The pressure exerted by the earth behind the piece acts as a driving force.

$\frac{\gamma h_1^2}{2} - 2 ch_1$. We now assume that the clay is quick, or at least sensitive, so that the reduction of strength in the two 45° slip surfaces through A transforms J_2 into a liquid pressure, with the result that J_2 rather quickly rises to a maximum¹ somewhere between the just mentioned active pressure and the value $\frac{\gamma h_1^2}{2}$. After that J_2 falls with falling h_2 until it is no longer able to prevent the next portion of the ground from slipping away. The active pressure, to which the earth pressure J_1 on the vertical plane through the remaining mass of clay may fall, is denoted by J_{1a} . It reaches its full value corresponding to the height h_1 in the vertical planes to the left of the point B, where a 45° line from C reaches the slide bottom; it is lower in the vertical planes to the right of B. We further assume that the retrogressive rupture at the slide bottom has at least reached point B, before the next slip occurs. Fig. 21 shows the pressure J_2 as a function of the horizontal distance x from point C to the point reached by the progressive rupture at the slide bottom; this diagram also gives J_{1a} in the vertical plane through point x . The next slip occurs when h_2 becomes low

¹ This temporary high pressure not only keeps the soil to the left of AC stable, it also accelerates the movement of the soil to the right of AC. Thus, it explains the violent horizontal translation, and it helps to explain the large horizontal extension of the slide.

In the case of an inclined slide bottom the mechanics of the slide can naturally be considered in a way similar to that used in Fig. 20. Then the component of the weight of the slipping ground along the shear surface also acts as a driving force.

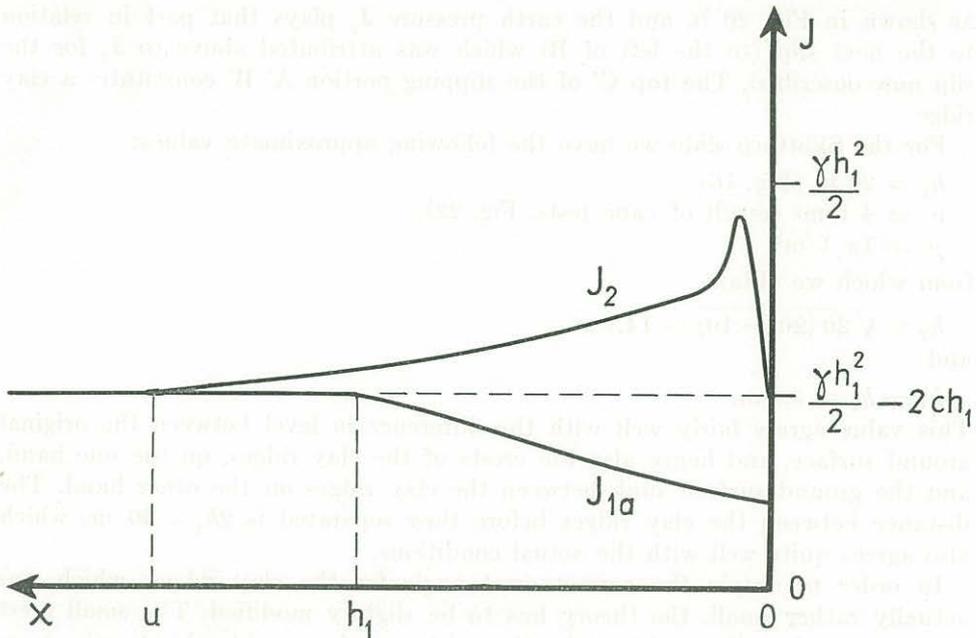
Fig. 21. Earth pressure produced when ground slips according to Fig. 20. J_{1a} = active pressure on vertical plane at distance x behind top of latest slipping ground piece.

enough, so that J_2 can begin to fall below $(J_{1a})_{\max}$. The intersection of the curves J_2 and J_{1a} in Fig. 21 at a point, u , to the left of h_1 , implies that the failure at the slide bottom has then passed point B in Fig. 20 a. The new slip surface should start in (or near) point B, because the resultant of the active pressure in a vertical plane through B and the remaining resisting force in the slide bottom to the right of B is greater than the corresponding resultant for any other point. For points to the left of B the resisting force is somewhat greater than, and the active pressure is the same as, for B. For points to the right of B the resisting force is somewhat smaller, and the active pressure is considerably smaller, than for B. Portion BA starts slipping when

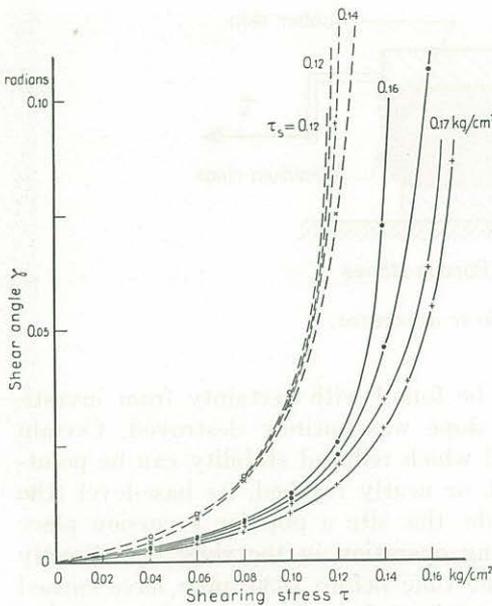
Fig. 25 Results of two series of direct shear tests. Consolidation pressure = 1 kg/cm². Water pressure in porous stones 0 for full curves and 0.2 kg/cm² for dash curves. Shear strength = τ_s .

In the first two series the shearing stress was successively increased to rupture, while the water pressure in the porous stones was kept at 0 in one series and at 0.2 kg/cm² in the other. The results are shown in Fig. 25. As seen, the shear strength was reduced from between 0.16 and 0.17 kg/cm² to between 0.12 and 0.14 kg/cm² when the water pressure was increased from 0 to 0.2 kg/cm².

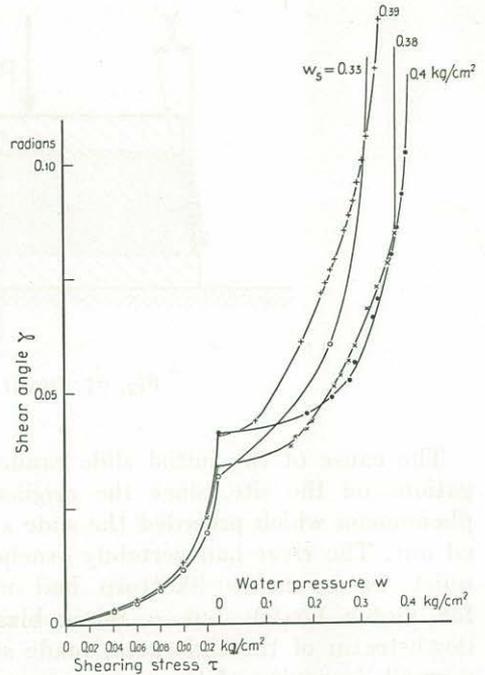
Fig. 26. Results of a series of direct shear tests. First, consolidation at 1 kg/cm². Then shearing stress 0.12 kg/cm² applied. After that rising water pressure (w) in the porous stones. w_s = water pressure at rupture.

The third series of tests resembled more directly the conditions prevailing under an increasing ground water pressure in sand layers in the clay *in situ*. After the normal pressure had completed its action, a shearing stress was applied and successively increased to 0.12 kg/cm². It thus equalled the lowest shear strength in the preceding series. Then the water pressure in the porous stones was increased. As shown in Fig. 26, rupture was obtained at the water pressure of 0.3 to 0.4 kg/cm².

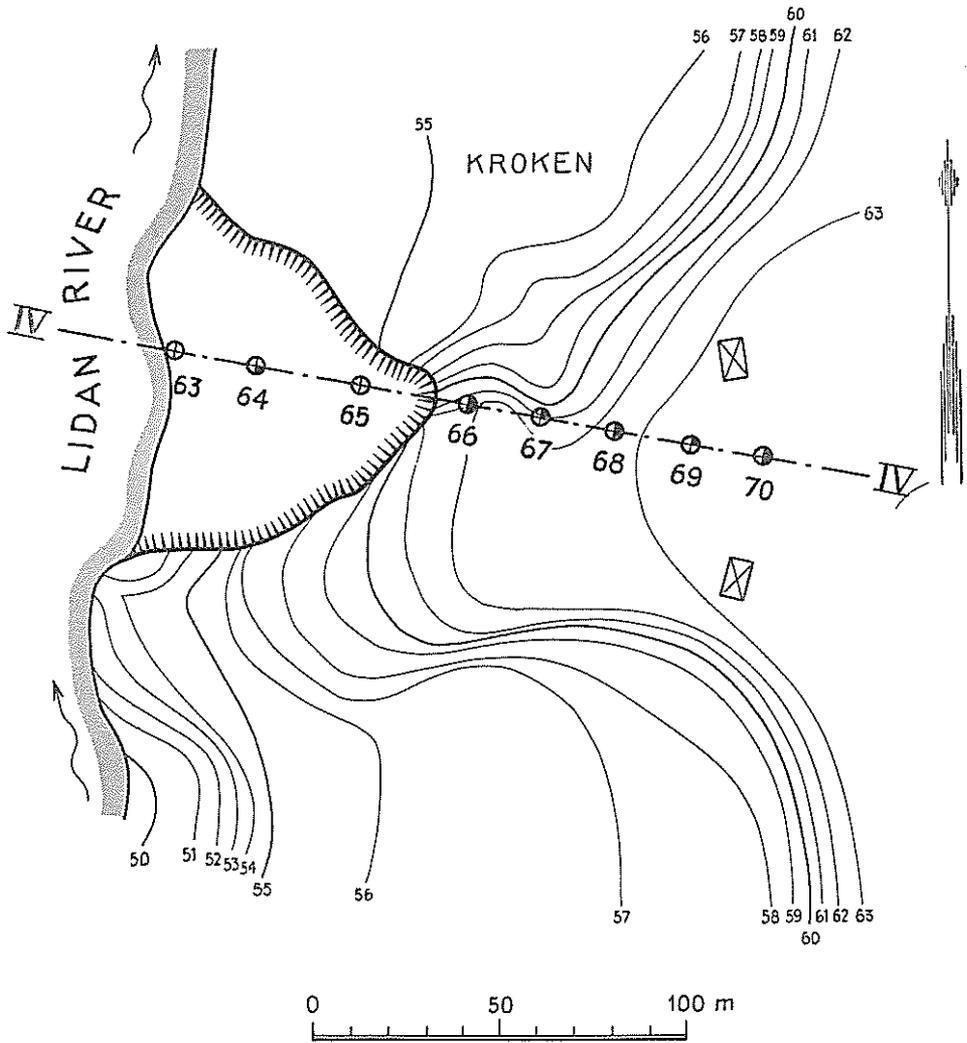
Fig. 29. Map of slide at Kroken. Contour lines refer to ground surface.
For key to symbols cf. Fig. 3.
